DESIGN DIVISION TECHNICAL REPORT

PHILADELPHIA NAVAL SHIPYARD
PHILADELPHIA, PENNSYLVANIA

COLLECTION OF LETTER REPORTS
OF VIBRATION SURVEYS
ISSUED DURING 1962

F. A. HEINZE
AND
D. S. BROGDEN

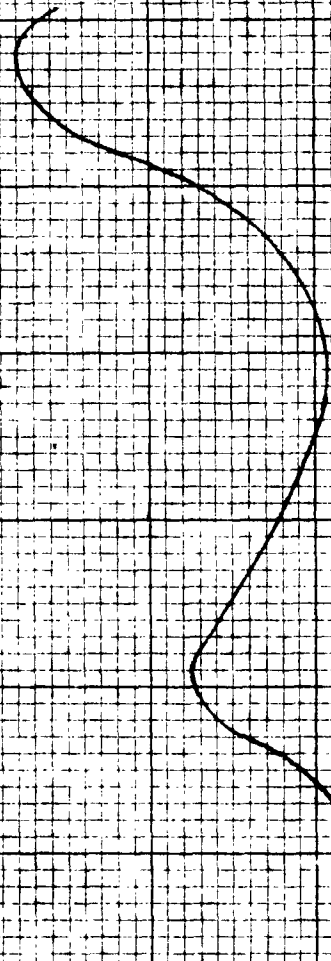
PHILADELPHIA
SHIP REPORT 265-29
SHEET 3 OF 3

5. The results of the survey are presented on *sheet (3) of (3)*. Two distinct first order (one vibration cycle per shaft revolution) critical speeds are present. The lower critical speed was 240 RPM with a displacement amplitude of ± 8.7 mils. The upper critical speed was 315 RPM with a displacement amplitude of ± 14 mils.

6. Based on measurements on a great many vessels, the New York Naval Shipyard Material Laboratory has established the tolerable limit of ± 18 to ± 20 mils (measured on the O2 level approximately frame 74) for first order athwartship vibration on this class vessel. Therefore the hull vibration amplitudes measured on this vessel are considered acceptable.

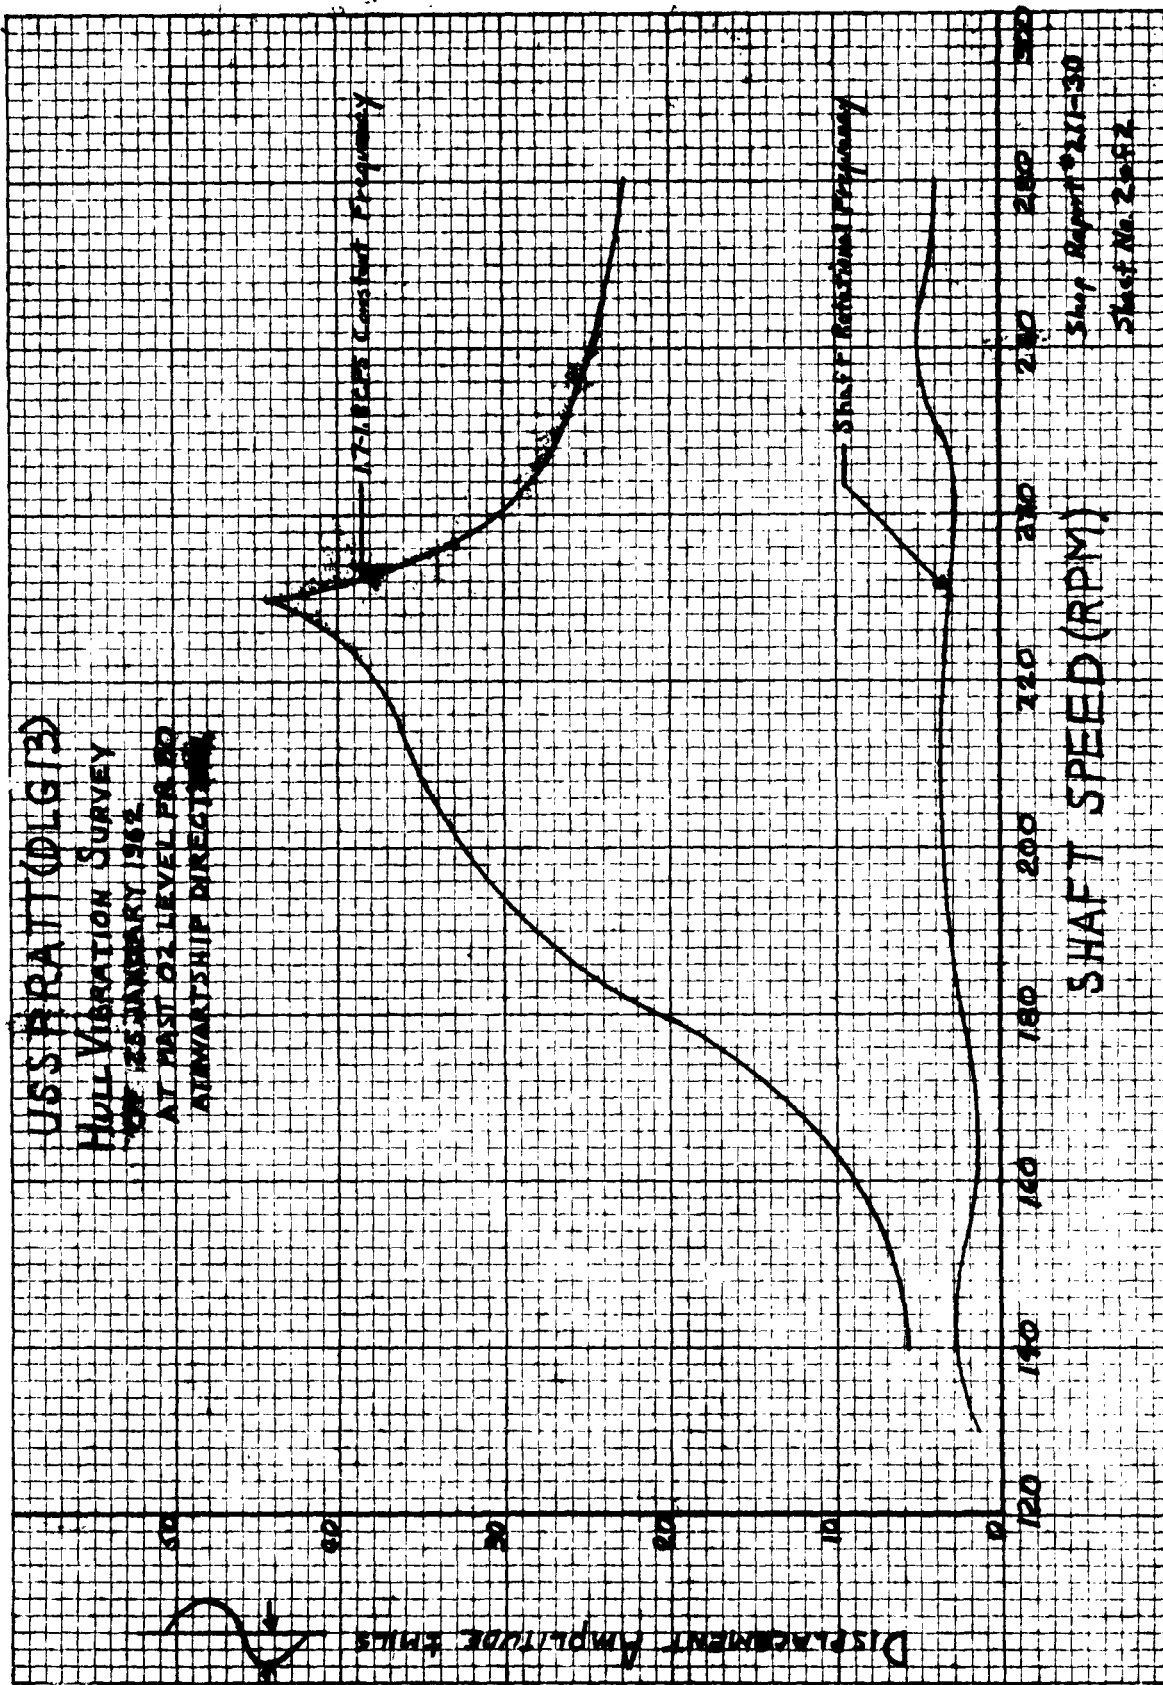
Sheet No. 2 of 2

3. The results of the survey are presented in graphical form on sheet 2 of 2 of this report. There does not appear to be any first order (one vibration cycle/shaft revolution) critical speed present. The maximum displacement amplitude of the first order vibration was ± 5.0 mils at 260 shaft RPM. Propeller blade frequency vibration (4th order) was observed from 130 to 250 RPM but never exceeded a displacement amplitude of ± 0.5 mils.

4. The most prevalent vibration observed throughout the speed range was a 1.7-1.8 cps constant frequency which is independent of shaft speed and most likely hydrodynamically excited. A critical occurred at 230 RPM with a displacement amplitude of ± 44.6 mils.

5. The hull vibration amplitudes measured on this vessel are considered to be acceptable.

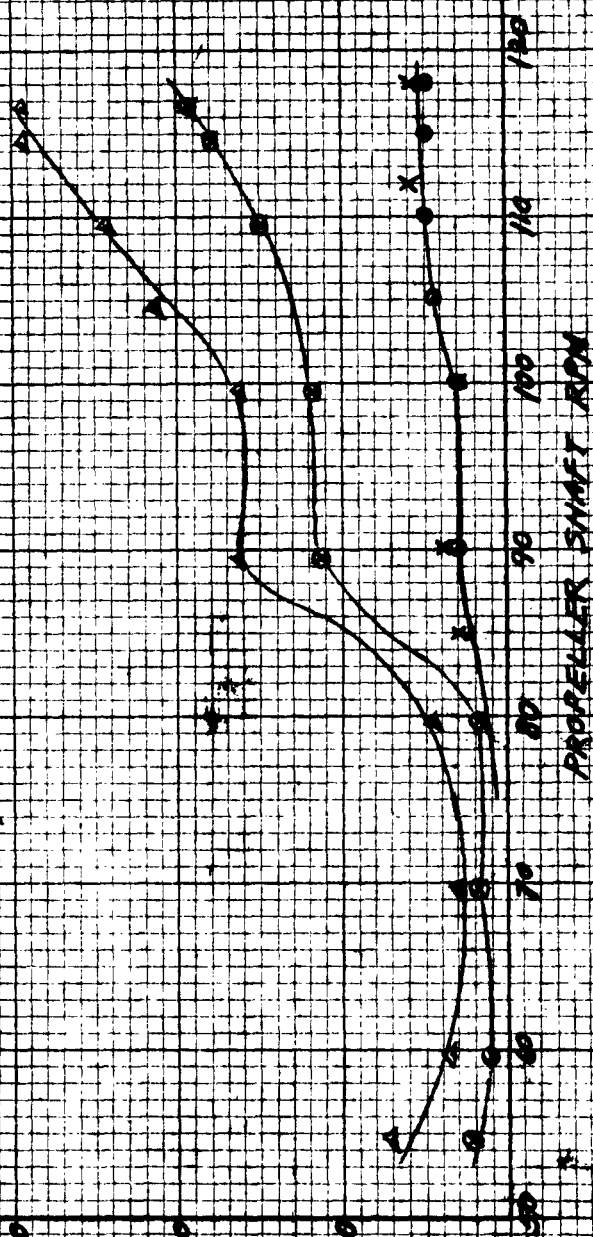
FIGURE 2

4. Results of the measurements at the towing pad, Frame 141, are plotted in figures 1 and 2 of enclosure (1). Data obtained on USS IWO JIMA (LPH-2) at 15,900 tons displacement on 10 January 1962 are plotted for comparison. It should be pointed out that vibration levels during hard turns are far from steady and the maximum amplitudes were found to vary considerably between various turns at the same rudder angle and speed. Therefore, the comparison between LPH-2 and LPH-3 in hard turns should not be given too much weight.

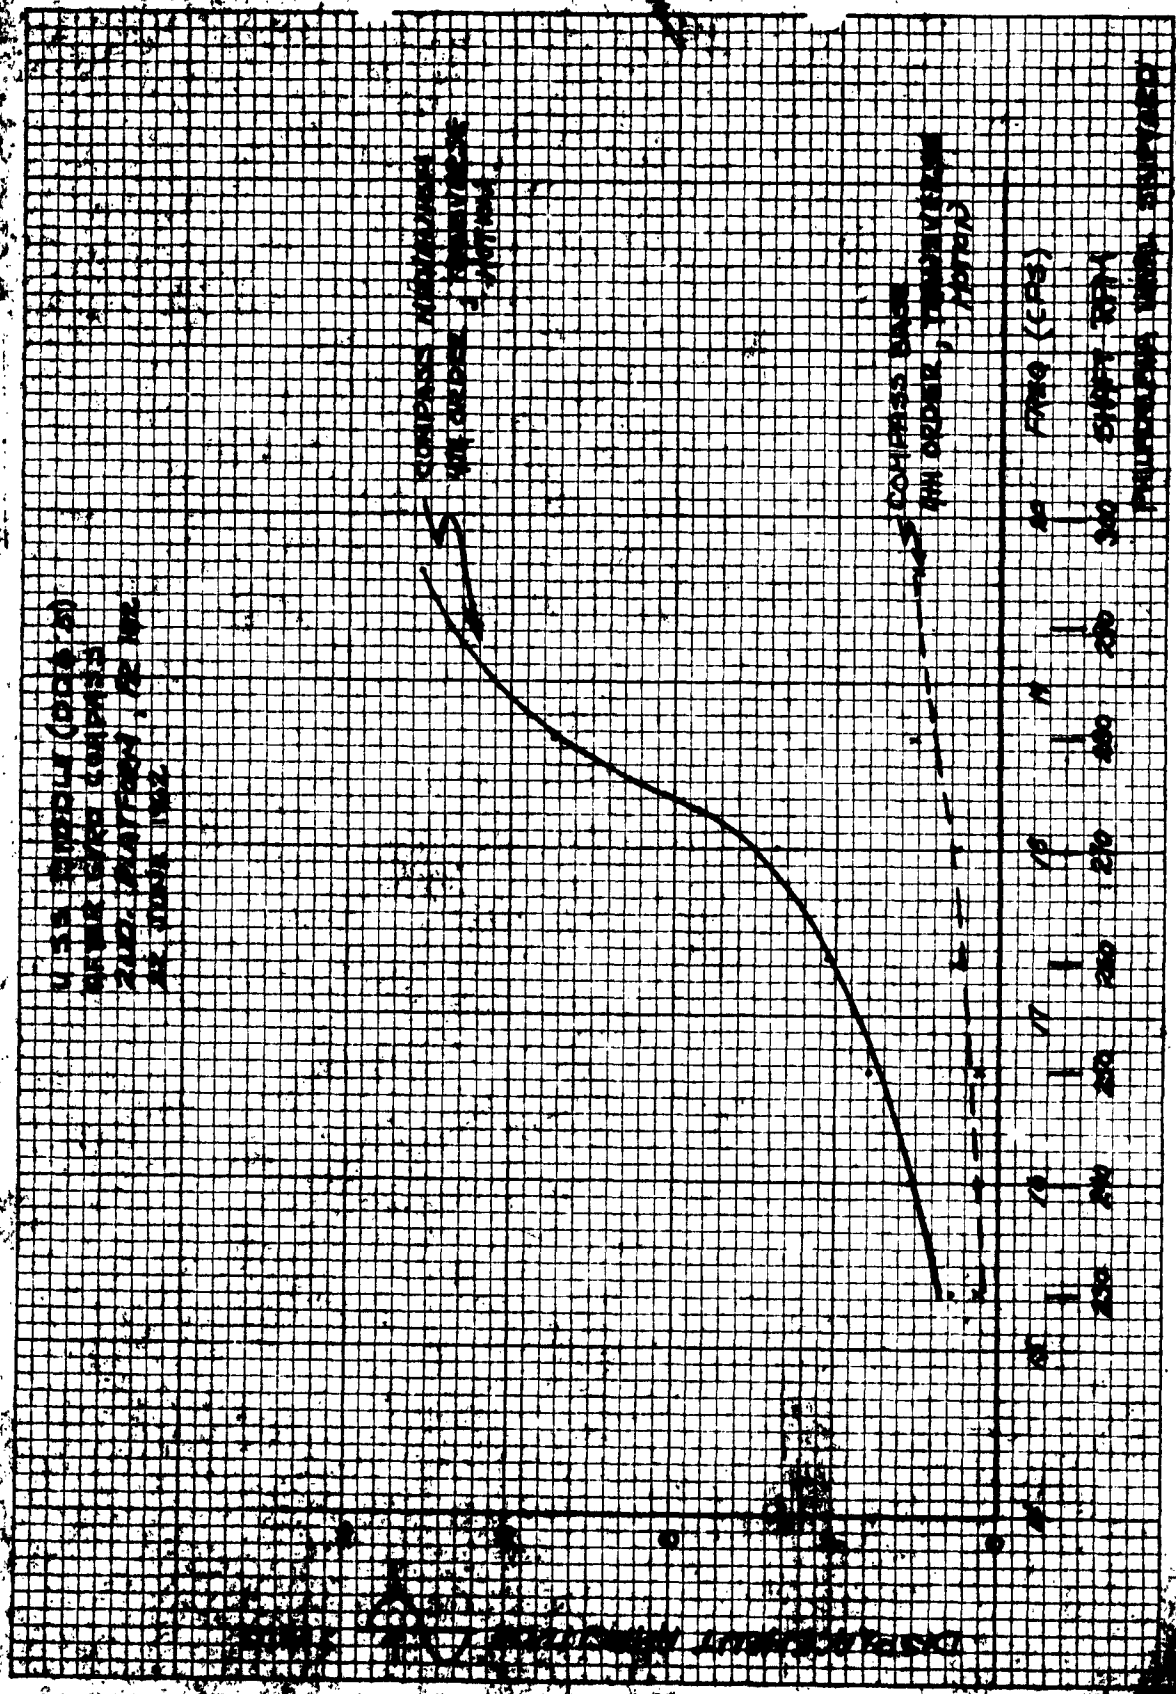
ENCLOSURE (4)

b. Although an apparent resonant or near resonant condition exists in the after gyro compass at full power, the Bureau of Ships does not consider the amplitudes excessive. Therefore, it is recommended that ship's force continue to observe the gyro compass to determine whether any operation or maintenance problems exist due to vibration.
